HAWK MOUNTAIN DAM

NDI ID No. PA-01129
DER ID No. 54-180

PHASE I INSPECTION REPORT

⑥ NATIONAL DAM INSPECTION PROGRAM.

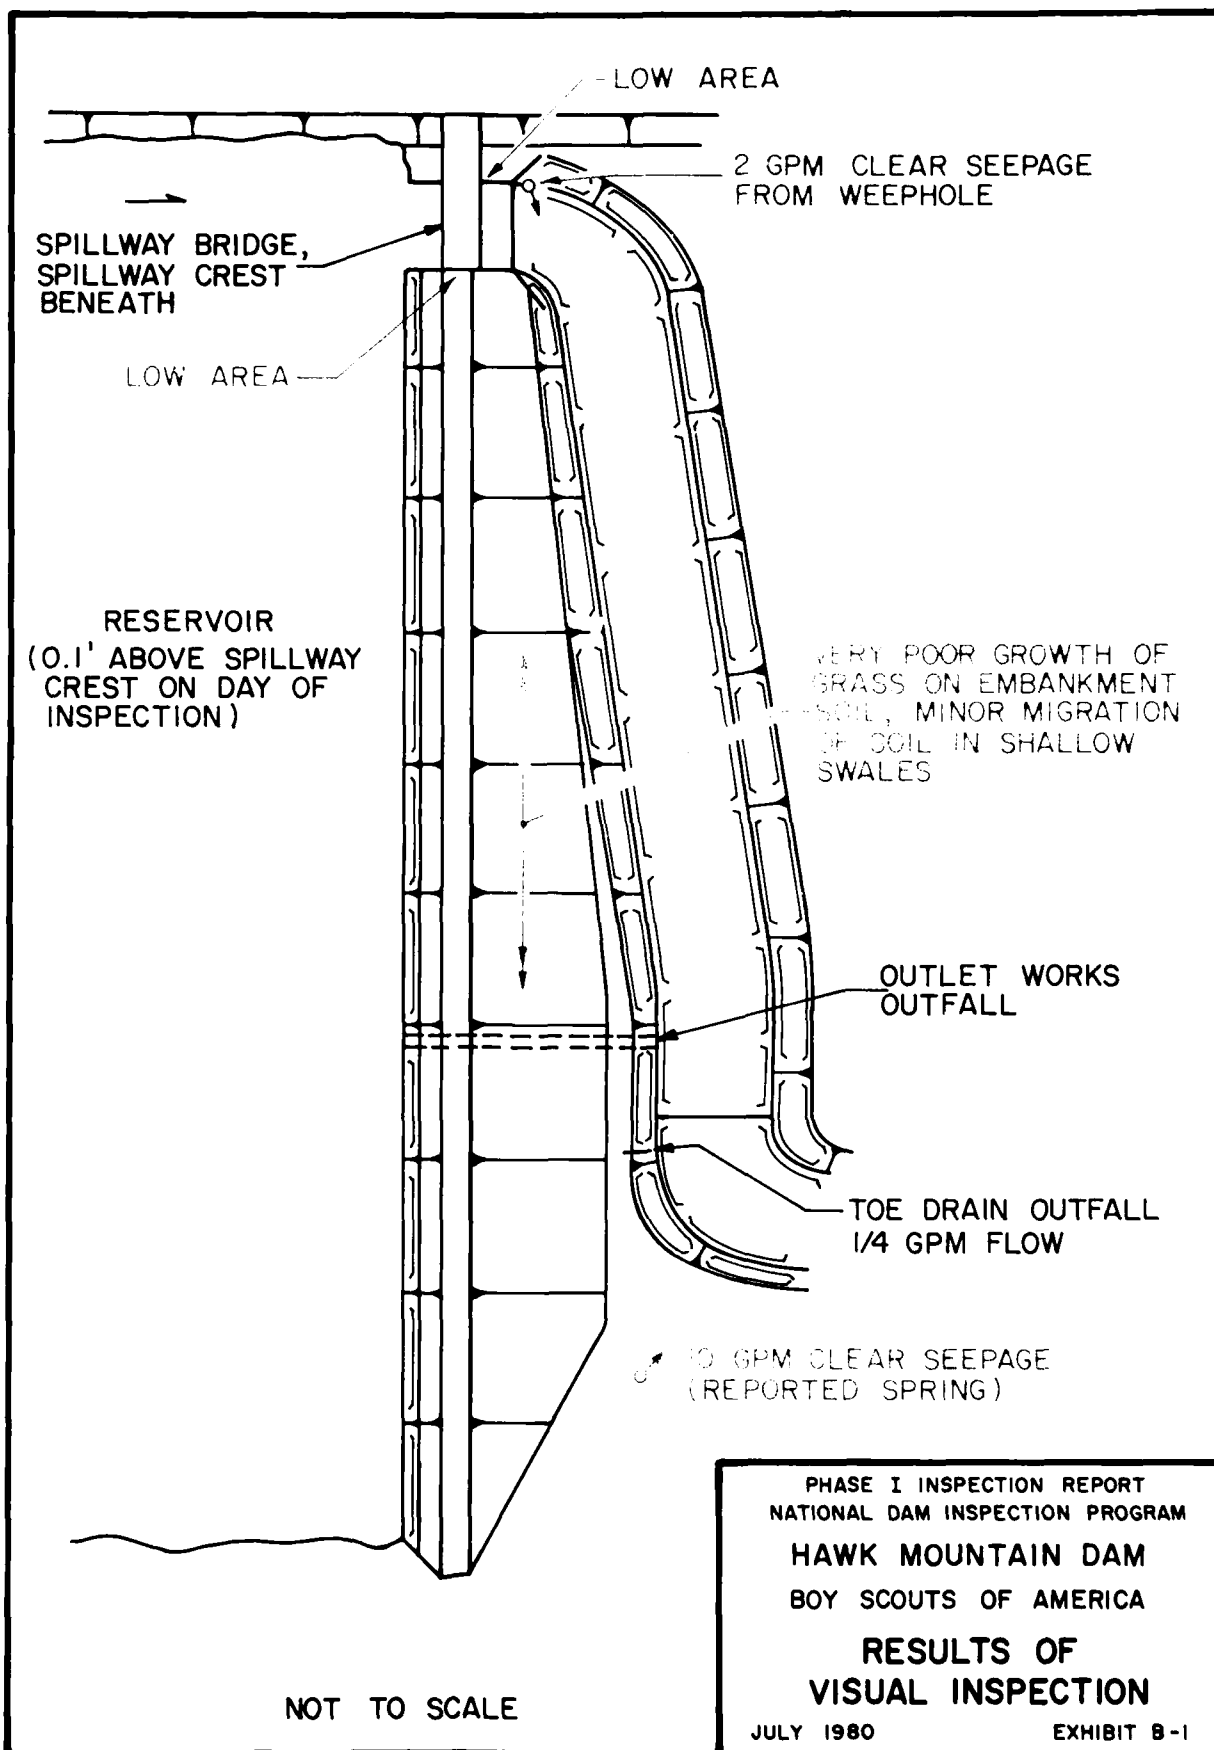
PHASE I INSPECTION REPORT
NATIONAL DAM INSPECTION PROGRAM
HAWK MOUNTAIN DAM
BOY SCOUTS OF AMERICA
RESULTS OF
VISUAL INSPECTION

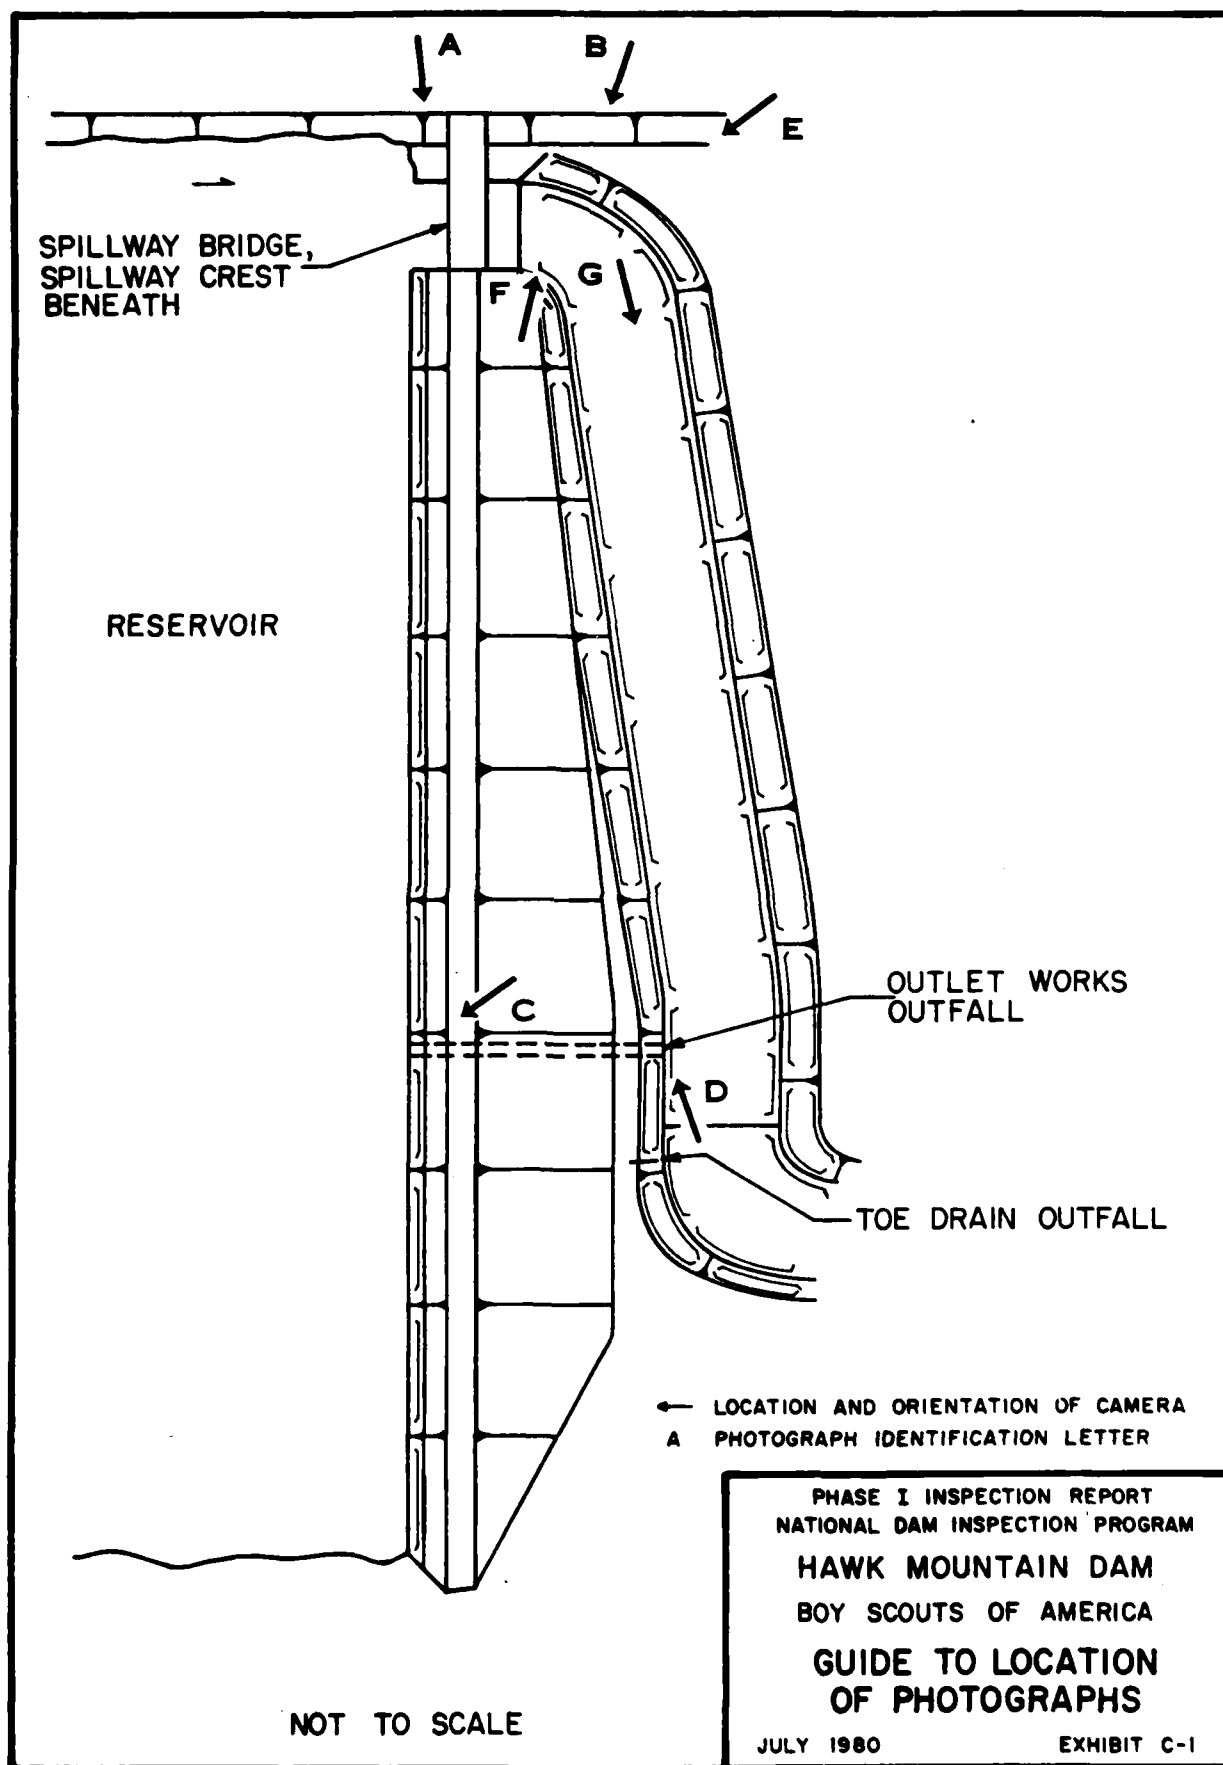
F. Spillway Left Wingwall

(Photographs A and E). The only deficiency observed at the area was significant seepage of about 2 gpm from one weephole at the left downstream wingwall (Photograph F). The spillway bridge is also in good condition. The spillway exit channel is protected by large riprap, which is in good condition.

(2) Visually monitor the seepage near the right abutment and at the spillway wingwall on a daily basis. If either significant changes in seepage or turbidity are noted, have the condition evaluated immediately by a professional engineer experienced in the design and construction of dams.
